NON-DESTRUCTIVE TESTING METHODS FOR EXAMINATION OF FAILED PLASTIC PARTS

Eric A. Beebe, E.I.T., Kevin W. Hollander, Ph.D., David S. Komm, P.E. and Todd A. Springer, E.I.T.
Augsburger Komm Engineering, Inc.

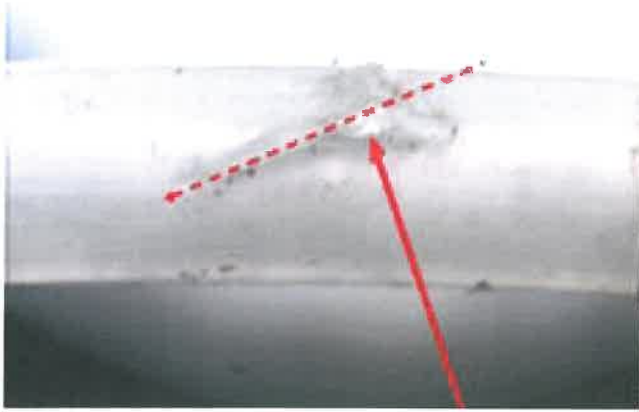
Figure 1: View of compromised section of tubing

A visual examination of a failed polypropylene water line revealed multiple locations with adhesive residue, as well as a number of surface abrasions and cuts. However, a microscopic evaluation, utilizing backlighting techniques identified specific features that led to the determination of the cause of failure. Figure 1 provides a view of the compromised portion of tubing discovered during this examination.

In Figure 1, the solid arrow indicates the point of breach and the thin dashed arrow denotes the probable direction of the puncture that caused an uncontrolled release of water.

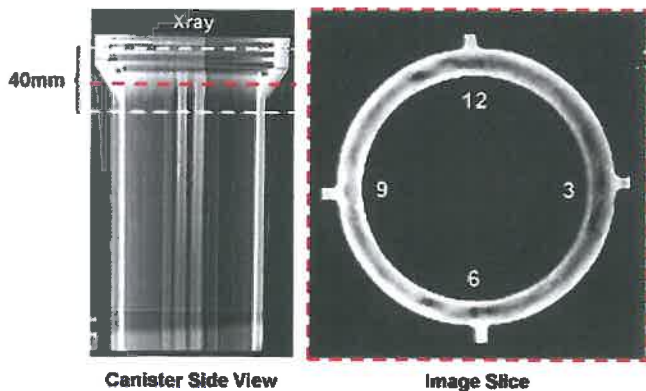
Figure 5: CAT scan images of failed filter.

The image on the left side of Figure 5 is an X-ray profile view of the failed canister. The section above the white dashed lines indicates the scanned region of the part. Looking closely at this image, it can be seen that the fracture is located just above the red dashed line.

The image on the right side of Figure 5 provides an image from the CAT scan data. The image shown corresponds to the red dashed line visible on the X-ray profile image. The CAT scan data revealed the part to be solid through its cross-section. However, the image did show a number of variations within the material.

Some variations are partially due to geometry changes in the part. However, due to the symmetry of the part, the majority of these variations can be attributed to changes in material density. All three canisters were scanned and demonstrated similar variations in material density, although the magnitude of density change for each is not known.

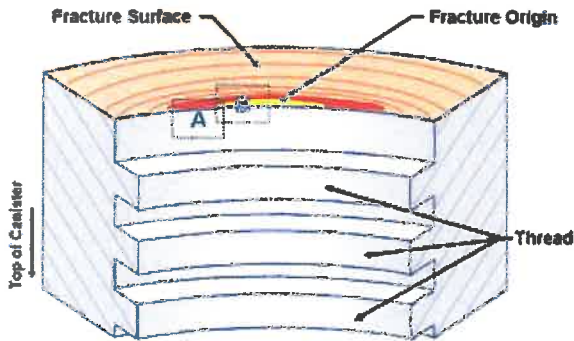
Figure 11: Diagram of SEM sample Section #2 and fracture surface features.

A diagram of Section #2 is shown in Figure 11. The diagram illustrates general part geometry examined and the relative locations of fracture surface features and SEM imaging.

The diagram represents a view the interior/threaded portion of the canister section examined. The fracture surface of this section features a brittle failure area identified by the yellow and red filled ellipses and is the failure origin. Emanating from the origin are bands or striations indicative of fatigue crack propagation.

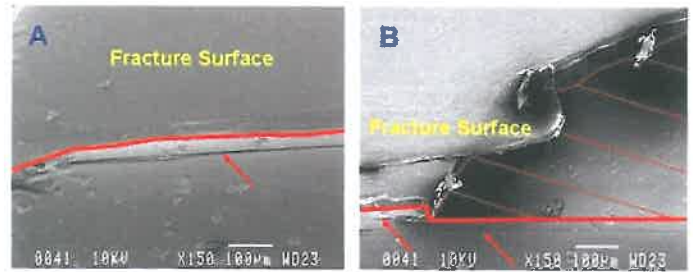
Figure 12: SEM images results.

Figure 12 shows two of the SEM images recorded during the examination. The relative locations where these two images were taken are illustrated by the boxed A and B in Figure 11.

Figure 12A is an image taken near the outer edge of the brittle fracture region. The red arrow in Figure 12A shows a crack formation that is parallel to and just below the fracture surface, indicating a secondary layer of separation.

Figure 12B is an image taken closer to the center of the fracture origin area. Again the thick red line indicates the transition between the horizontal surface of the fracture and the vertical face of the thread root. The red line hatched region in Figure 12B indicates a lower elevation from the primary fracture surface. The two surfaces are parallel to one another. In fact, a closer examination of the step up region between them appeared to show the lower surface continuing to extend beneath and parallel to upper fracture surface.

The red arrows in Figure 12B show very straight grooves on the vertical face of the thread root that are parallel to the flat fracture surfaces in this region. Following the bottommost groove to the left, it eventually becomes the crack observed in Figure 12A (red arrow).

The parallel layering of the canister material in the region of the failure origin implies a lack of bonding between these layers. Un-bonded layers of SAN or any material will significantly reduce a part's overall effective strength. A weakness in the threaded region of the subject part is consistent with the findings before destructive testing and the failure is congruent with a manufacturing defect.
