Forensic Engineering Investigation of Basketball Goal Support Failure

David S. KOMM, P.E., C.F.E.I.; Quent AUGSPURGER, P.E.; Hugh J. MCSPADDEN

Augspurger Komm Engineering, Inc., 3315 E Wier Ave., Phoenix, Arizona 85040, USA

Abstract: This paper describes the forensic engineering analysis done to identify the probable cause of failure of one basketball goal support pole, positioned adjacent to a residential driveway in central Arizona. The abrupt failure of the pole portion of the goal system caused a fatality. This paper describes the collection of evidence, development of a probable scenario, and testing done to confirm the scenario. Major contributing factors reviewed included the manufacturer's instructions, site preparation, anchoring of the pole, and the actual installation. Metallurgy and other factors were also examined to identify the probable cause of failure.

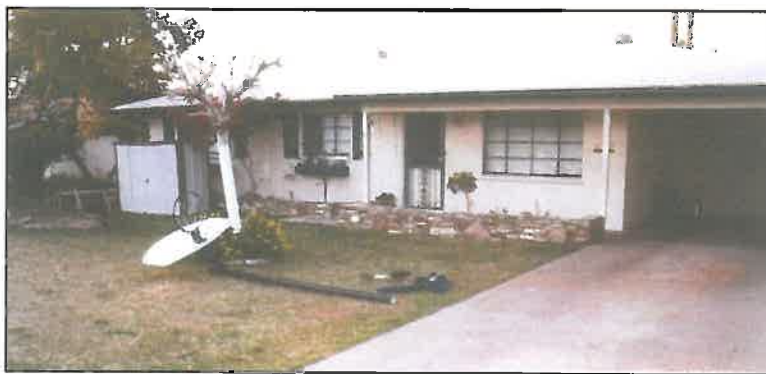
Photo 1a². Broken pole in yard.

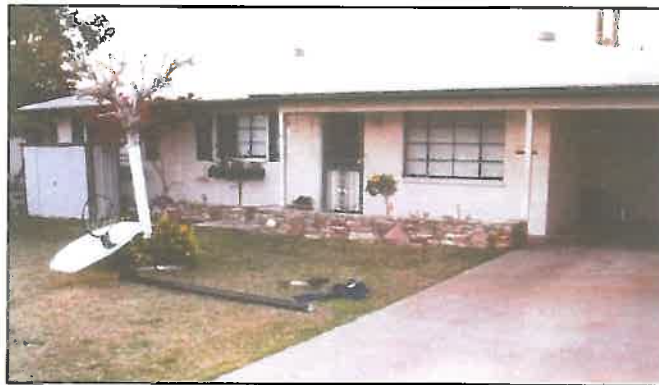
Photos^[2] taken on the day of the accident show the location of the fallen pole. The photos also show significant corrosion of the pole extending a few inches above the break, as well as the concrete filling the inside of the pole and the fact that it failed in a brittle manner.

Photo 1c^[2]. Location Of Fallen Pole

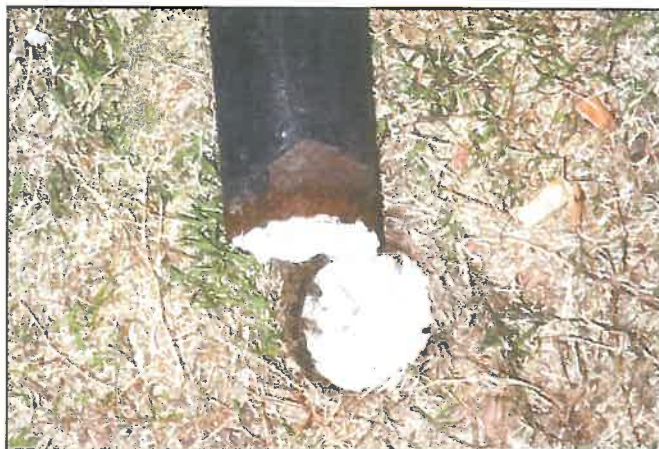
Photo 1d^[2]. Close-up Of Broken Pole, At The Break.

Close visual examination of the broken end of the subject pole was done, and showed the presence of the unreinforced concrete, as well as obvious thinning of the tube wall by corrosion (rusting).

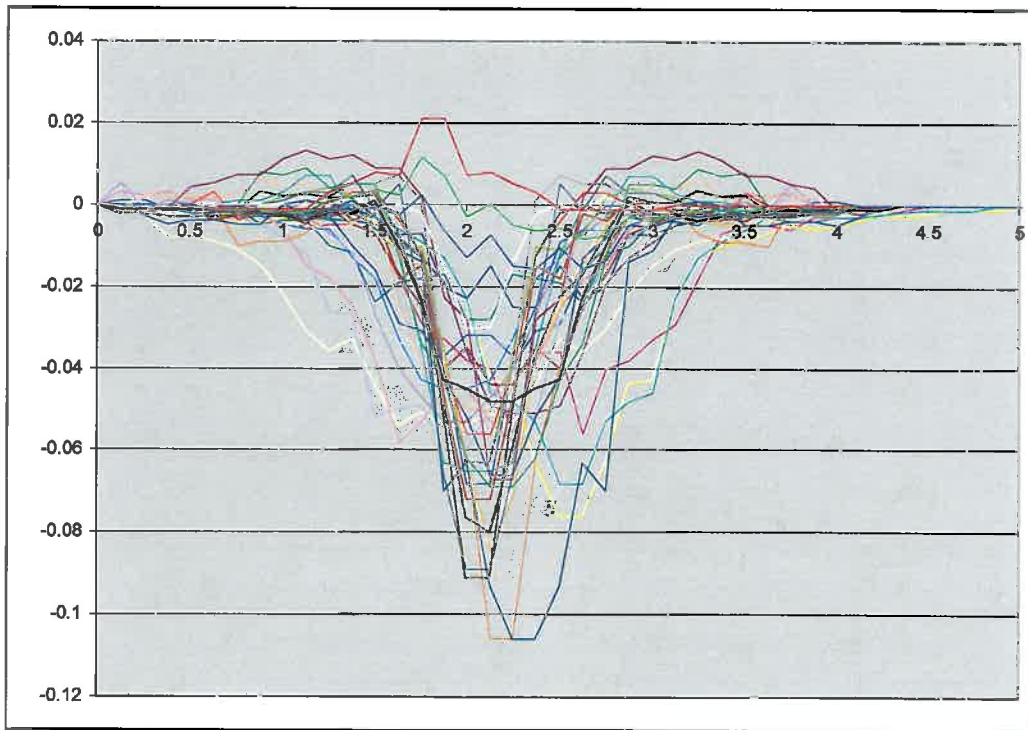
Figure 1. Plot Of Initial Measurements Of Missing Metal Of Pole.

Analysis of the raw data showed a sinusoidal variation of the remaining steel thickness. After allowing for rust on one or both surfaces of the tube as appropriate, the thickness of the remaining steel was calculated to be 0.004 to 0.034 inches. The following graph shows the change in wall thickness, as measured on the subject pole. The measurements have been “mirrored” to provide a probable profile above and below the break. The measurements clearly show a “necking” effect as well as the off-center (sinusoidal) variation of the remaining wall thickness

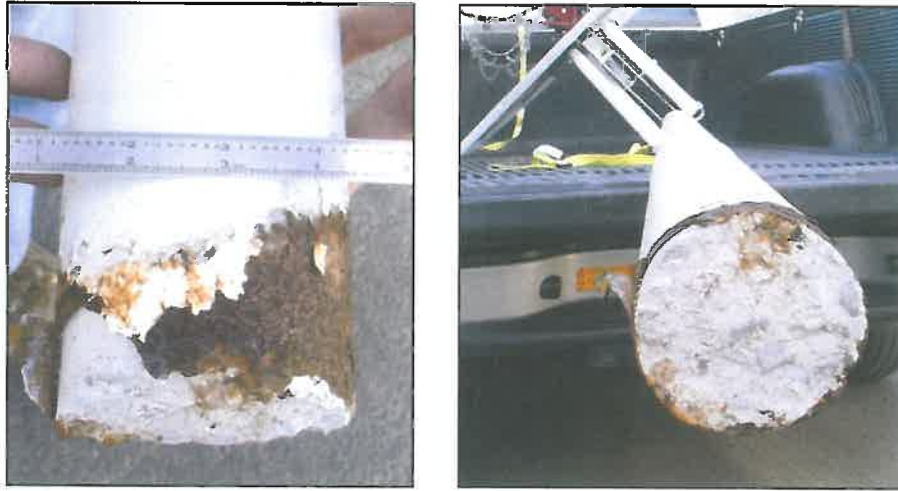
Photos 3a and 3b. Close-ups Of Exemplar Pole

The corrosion noted on this exemplar pole is very similar to that of the subject pole, and the pole metal was weakened enough that a portion of the tube wall offered little resistance to bending and possibly even tearing during the removal of the pole. In addition, the rust found on the broken surface of the concrete is evidence that the concrete was at least partially broken, if not totally broken before the pole was removed by Augspurker Komm Engineering, Inc.. The rust also suggest the possibility that the pole had corroded all the way through in places. The broken end of the pole was located flush with the concrete footing.

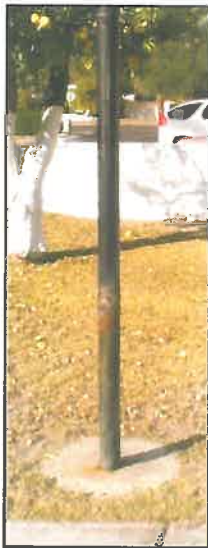
Another installed pole, shown in the following two photos, has corrosion in two places: (a) adjacent to the concrete base and (b) at the junction of the lower and middle pole segments.

Photo 4a. External Rust On Second Exemplar Pole

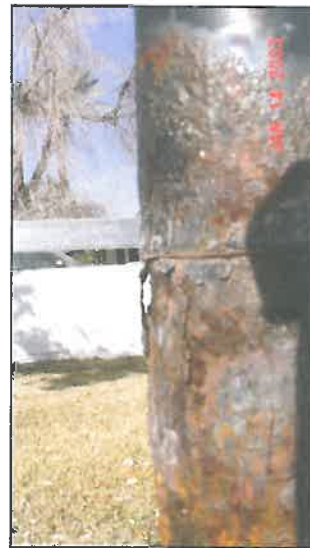
Photo 4b. Layers of Rust, Pushed Away From Pole Metal At The Joint Between The Lower And Middle Sections Of The Pole

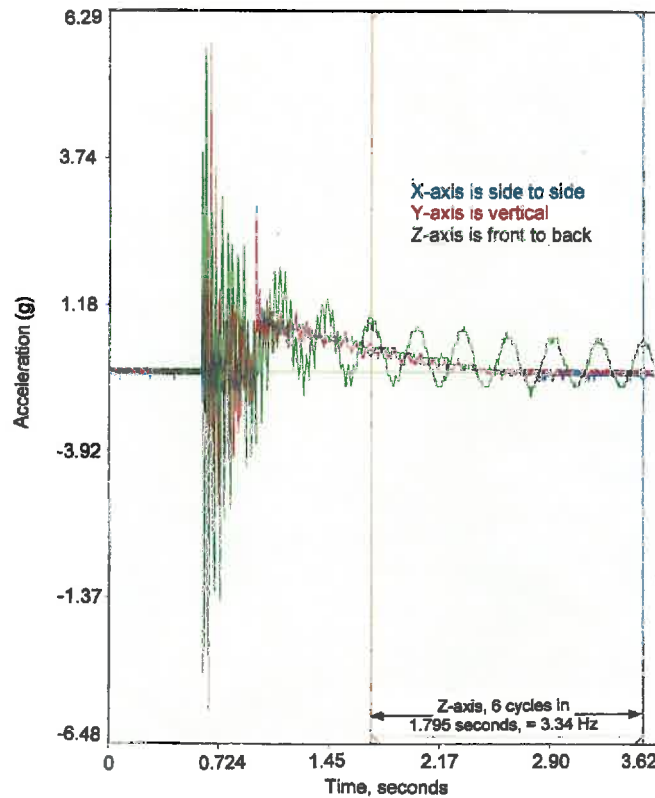
The testing of new poles used three-axis accelerometers to measure the vibration of the pole after the backboard was struck with a basketball. The resonant frequency of 3.34 Hz was measured by analyzing the records of approximately 20 impacts by a basketball.

Figure 2. Graphical Output From Resonant Frequency Test.

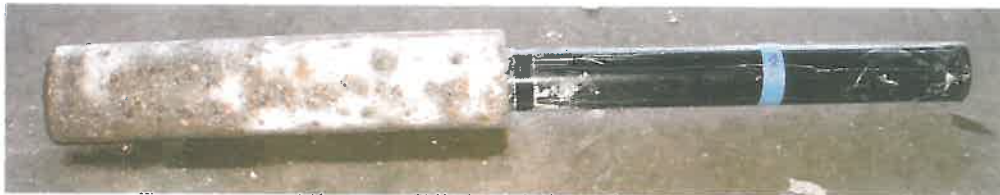
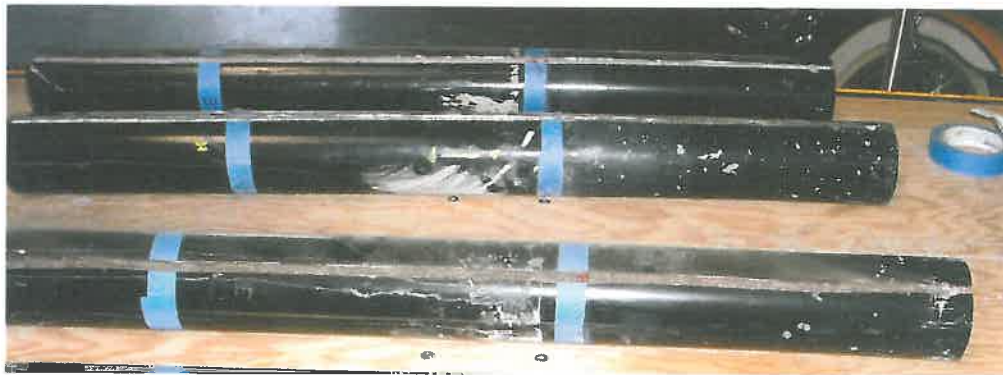
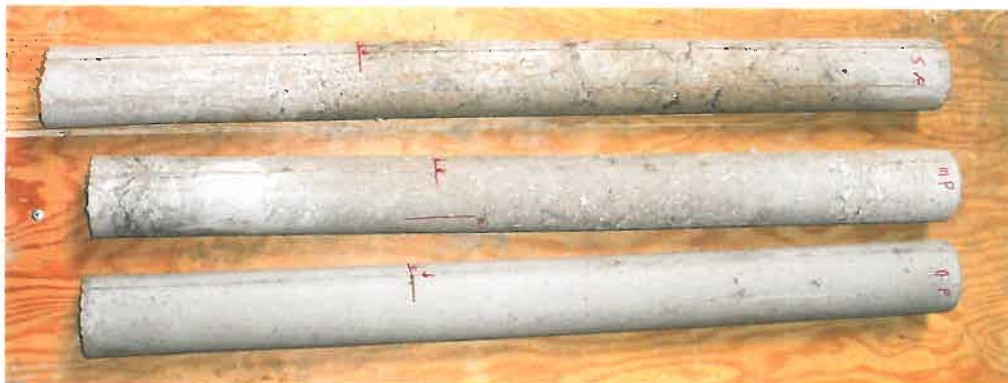
Photo 5a. Pole Section After Vibration, And Removal From Concrete Base.

Photo 5b. Pole Sections After Longitudinal Cutting, But Before Opening The Sections.

Photo 5c. Concrete From Pole Sections, Reassembled After Inspection.

Visual inspection confirmed all three concrete fillings were broken at a point corresponding to the depth of the outer concrete base. The concrete from each tube was in two pieces, with no bonding between the sections.

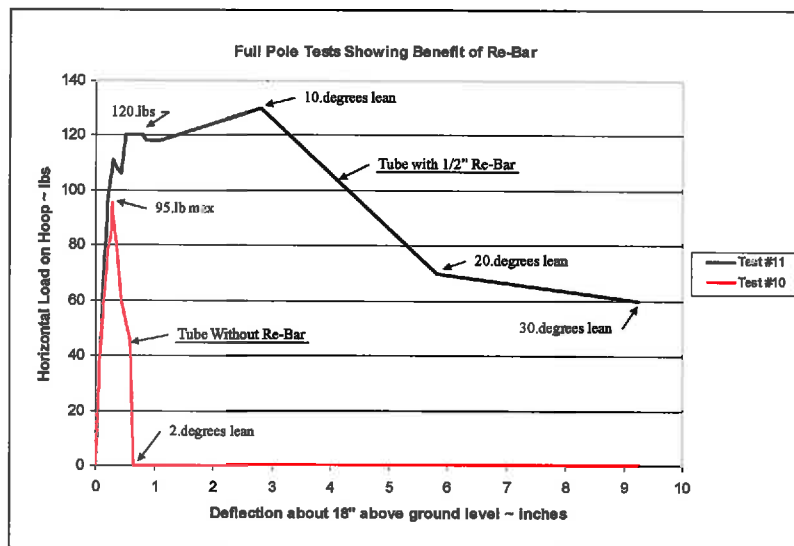
Two poles were tested for angular displacement prior to failure. One pole contained unreinforced concrete, and the other pole contained concrete reinforced with a 0.5-inch diameter steel reinforcing bar. The angular displacement was measured by a dial micrometer, and the degrees of bend calculated at intervals during the destructive testing. The testing was done by applying a tension load to the hoop of the goal until failure occurred.

Figure 3. Applied Forces, Versus Inches Of Lean Of Pole

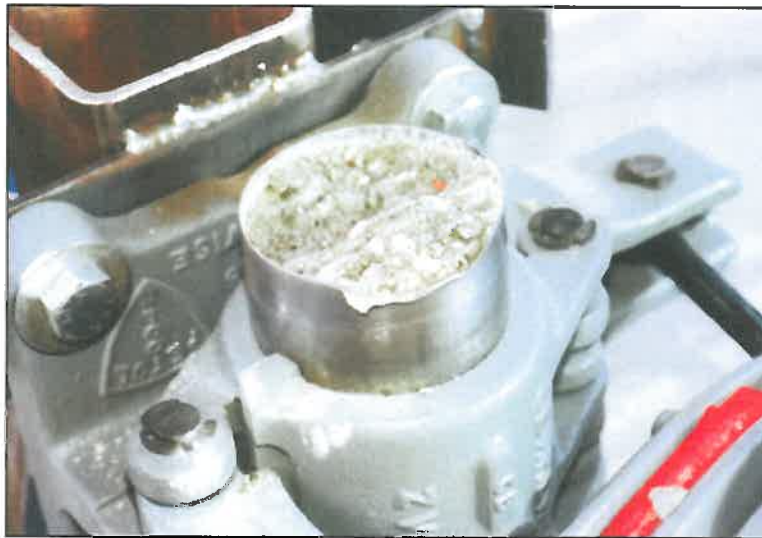
Tensile force was progressively applied to the hoop of the goal. Measurement of the force required was made with a strain gage load cell, monitored during the application of the tension tests. Failure occurred at the thinnest part of the machined section of the pole and the concrete broke with no reinforcing bar present in the concrete, shown in photos 6b and 6c.

Photo 6b. Machined Exemplar Pole Without Reinforcing Bar In Concrete, After Test.

Photo 6c. Close-up Of Failure Of Machined Exemplar Pole

Poles containing only concrete, without a reinforcing bar inside, failed abruptly and totally when subjected to bending tests that simulated the collapse of a corroded pole. The basketball goal assembly is top-heavy and once the steel failed, the concrete could not resist the bending forces. This failure occurred when the pole was deflected only a few degrees from the vertical.

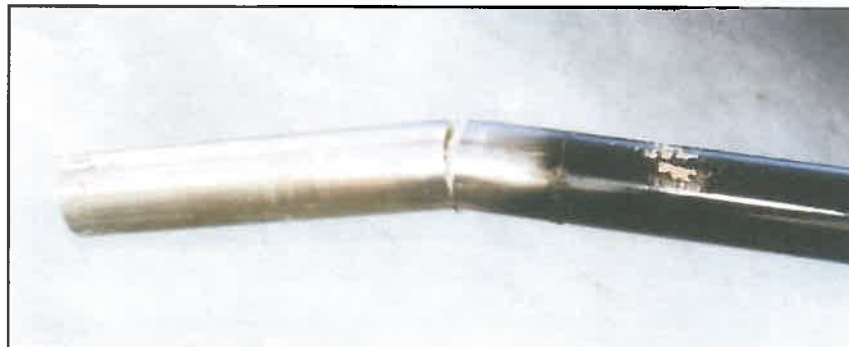
When a reinforcing bar was used in the concrete, the pole was bent and broken, with the concrete also broken. But the reinforcing bar provided significant strength, keeping the two portions of the pole together and thereby preventing a total collapse of the pole.

Photo 6d. Post-test Close-up Of The Exemplar Pole Containing The Reinforcing Bar In The Concrete.

In contrast, poles containing a reinforcing bar in the concrete filling did not fail in a catastrophic manner. The steel of the tube broke, but the pieces above and below the break remained connected, even when the upper portion was bent 30 degrees from the vertical.

Similar testing of an exemplar pole with the concrete containing a steel reinforcing bar clearly demonstrated the benefit of having the reinforcing bar: the metal pole was broken, the concrete was fractured, but the two portions of the pole remained connected to each other. The basketball goal assembly did not fall to the ground, even when the angle of bending clearly exceeded the angle required to cause failure in the exemplar pole without the reinforcing bar.

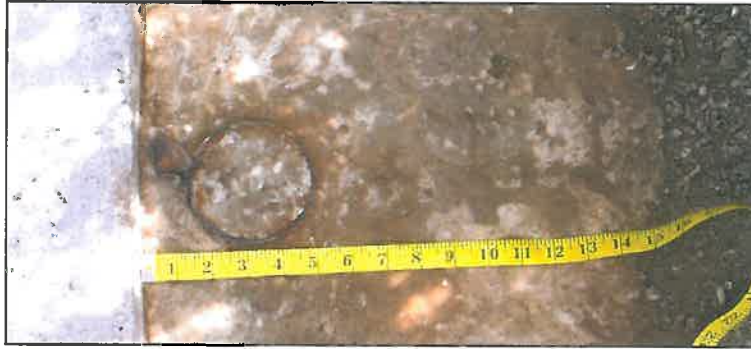
Additional pole installations were inspected, and all displayed similar patterns of corrosion: either adjacent to, or up to a few inches above, the top surface of the concrete anchor.

Installations inspected showed little or no drainage slope to the top surface of the concrete, and in some cases were uneven, indicating a lack of smoothing of the concrete during the installation. These and other factors increased the likelihood water would collect at the base of the pole, and potentially carry corrosive minerals to the pole.

Photo 7a. Corroded Pole Stub In Desert Landscaping

Photo 7b. Close-up Of Corroded Pole Stub In Desert Landscaping
