Non Destructive Examination of Plastics Failures

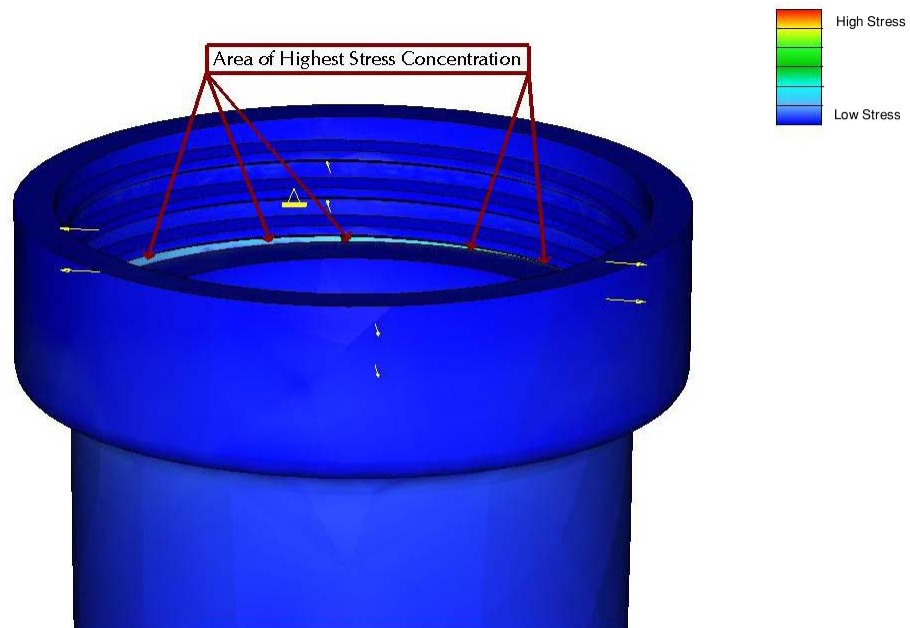
A recently completed water loss claim had a water canister which suffered a fracture, causing significant damage to a local business. Our findings were that the subject fracture occurred along one of the threads used to secure and mount the canister to the bonnet. This is a typical failure location in threaded components as it is this thread root that carries the highest stresses in the part. Stresses are concentrated in this region because of sharp geometry changes, known as stress risers, and a reduced cross-sectional thickness (the area is not as thick as that of a thread crest).

Figure 1 is a finite element model reflecting the highest stress region along the thread root:

The fracture was consistent with creep rupture, a typical failure mode in loaded plastic components. Over time, the stresses below the yield strength of the material relax the polymer chains, reducing the ultimate strength of the canister. When the ultimate strength of the part is reduced to that of the applied stresses, the part fails.

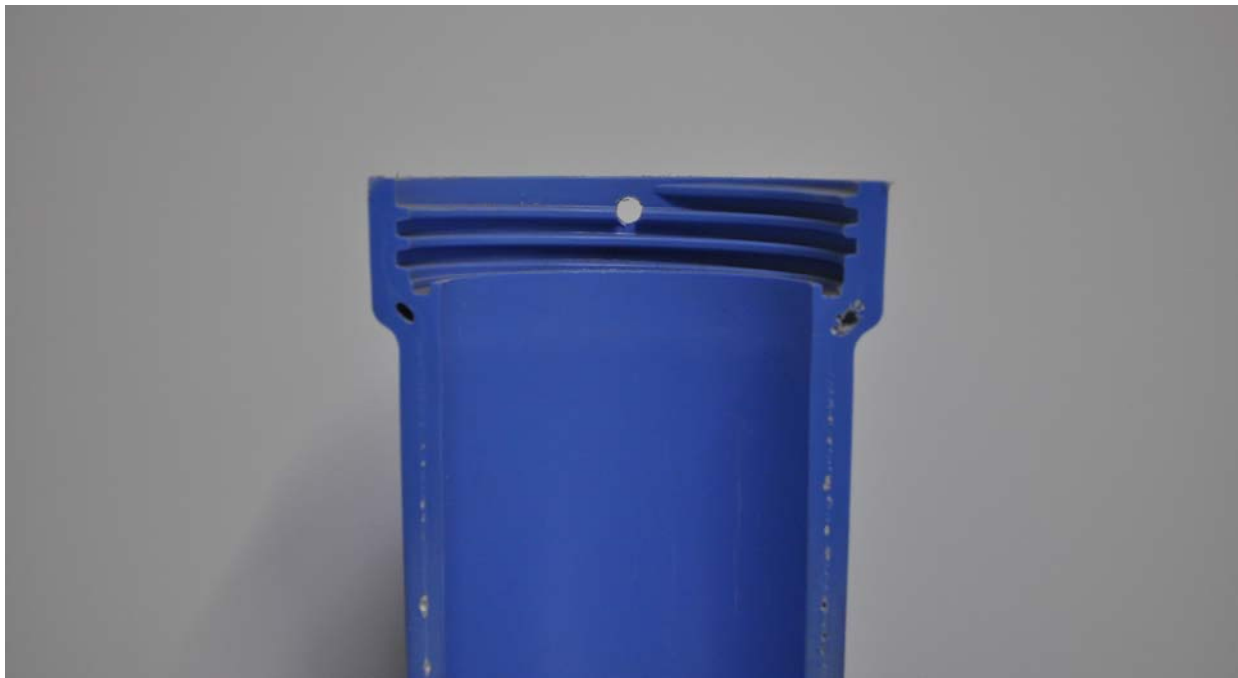
The subject canister had been in use for three years. Our experience suggests that canisters of this type which fail within five years are likely to have manufacturing defects, such as internal voids.

Figure 2 shows a cross section of a canister containing material voids as a result of poor manufacturing:

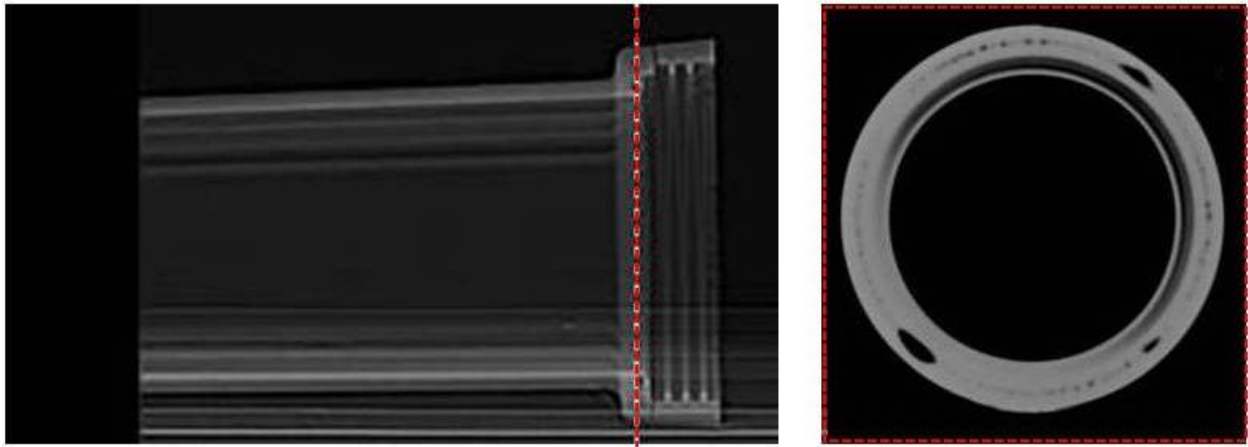
The image on the left side of Figure 3 is an X-ray profile view of a reverse osmosis canister. The set of red, dashed lines indicates the region scanned. Looking closely at this image it can be seen that the canister fracture is located just to the right of the red dashed line.

The image on the right side of Figure 3 shows an example image slice from the CAT scan data. The image slice shown corresponds to the red dashed line visible on the X-ray profile image. The CAT scan data showed the part is solid through its cross-section but contains areas of significant material voids.

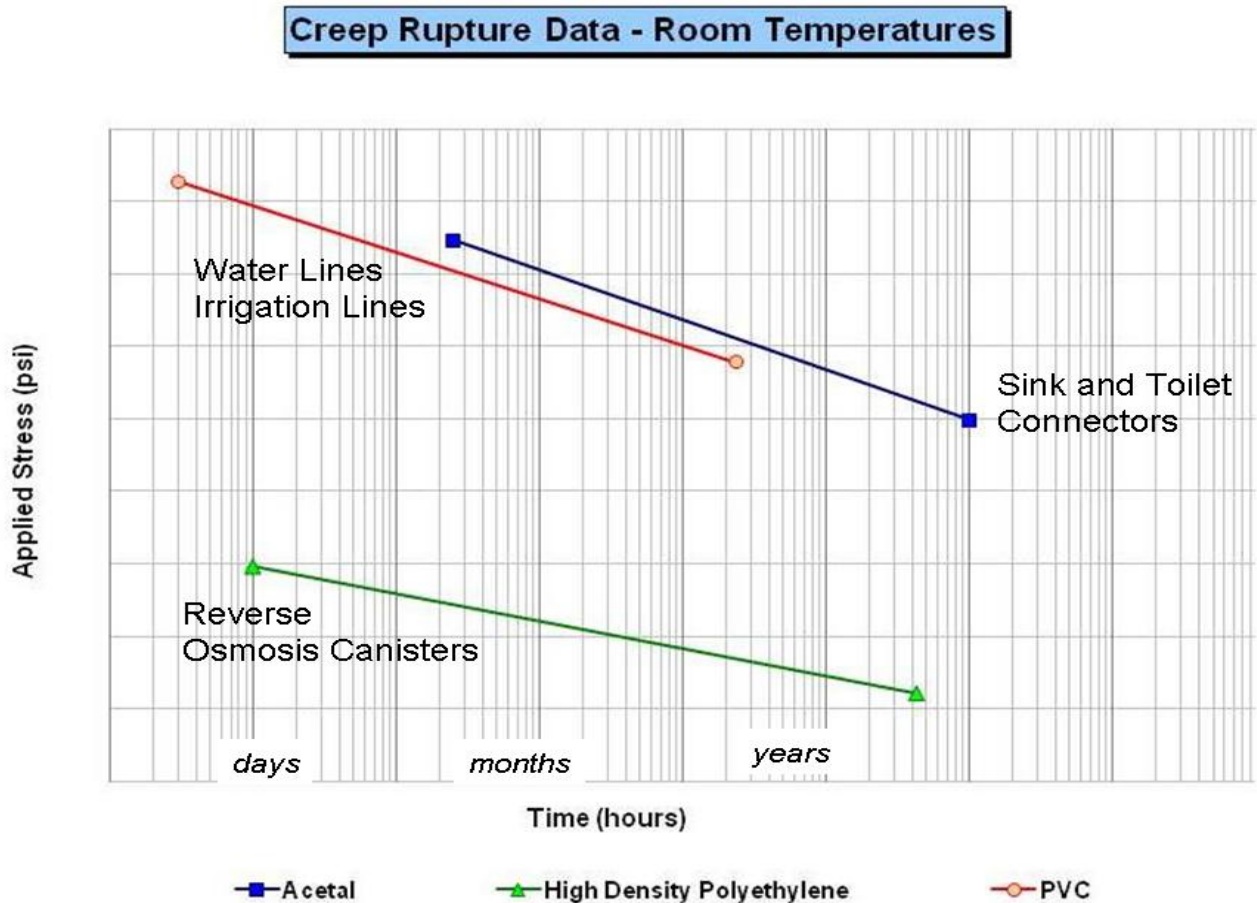
Creep life expectancies for some common materials can be seen in Figure 4. The logarithmic graph data contained in Figure 4 was calculated for average room temperatures. This information helps determine, under a certain amount of stress, such as water pressure, how long the part would likely last.
